Flawless Countenance

Quality Control in Cosmetic Packaging

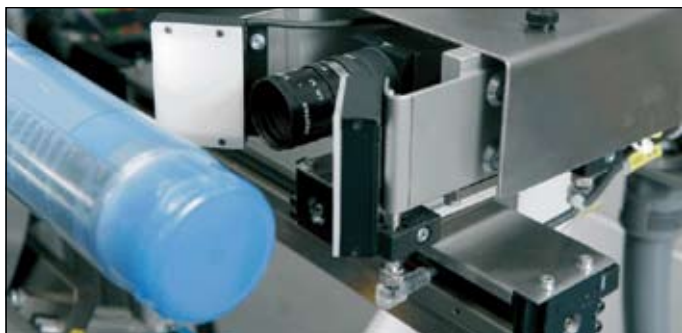
An array camera determines the exact radial and axial position using the tube's print image

In close co-operation with Madag Printing Systems, the manufacturer of the stamping machines, Signum has developed a 100% inspection system for this task. The machine is designed to perform 90 cycles per minute. The tubes are put onto mandrels on a turntable passing five stations. After the tubes have been placed, a registration mark sensor determines the approximate position at the second station. Subsequently, a surface camera determines the radial and axial position

accurate to 0.01 mm using the tube's print image to compare the object position to the target position. The PLC corrects the position, so that in the stamping station the accurate position of the stamping in relation to the print is guaranteed.

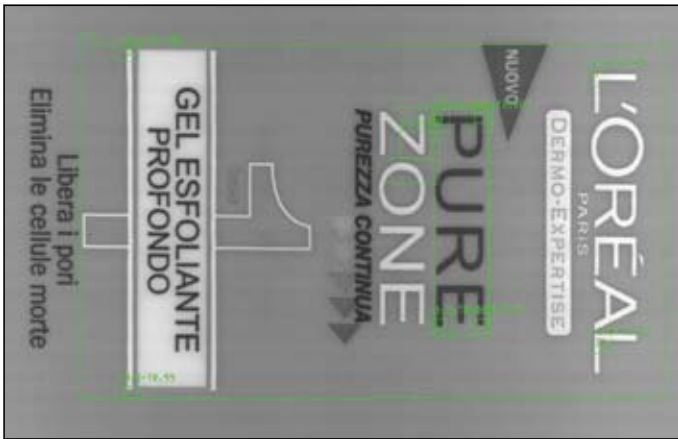
Developed surface of the front of the tube with foil print and inspection windows

Following the stamping, the tube is rotated under a line scan camera and the image of the circumference is compared to a reference image.

The illumination is selected in a way that the foil appears in reflection and therefore the background remains rather dark. Only in special cases the illumination is changed to dark field. Objects with a length of up to 200 mm can be inspected with a resolution of 0.1 mm/pixel. If required, the user can check also the imprint as well as the remaining surface for defects.

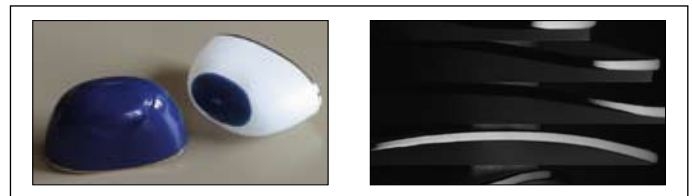
Oval Cap with hot foil print, image sequence of half a revolution, the second half is symmetric

In the example shown the contour is printed with a foil that is approx. 2 mm wide. Afterwards, the unit under test is put on a rotation device and is rotated 360 degrees. A progressive scan camera, which can be triggered asynchronously, takes 10 images while the object is

rotated one full circle, so that the stamped edge can be completely examined. The lighting is arranged in a way that for each point of view a diffuse reflexion is created for the area to be inspected. Since the reflexion angle varies strongly due to the curvature of the object, the light source must be rather large and positioned close to the object.

In order to start the image acquisition at the correct time, a trigger device is fastened on the rotation axis. This trigger device has to be changed whenever a part with a different shape is produced. Depending on the shape of the product, the im-

age sequence on the monitor looks different. For the extreme case of a round part all the images of a sequence look alike. The trigger distance of the rotation device may not be faster than 60ms. Beyond that no demand is made against the uniformity of the rotation.

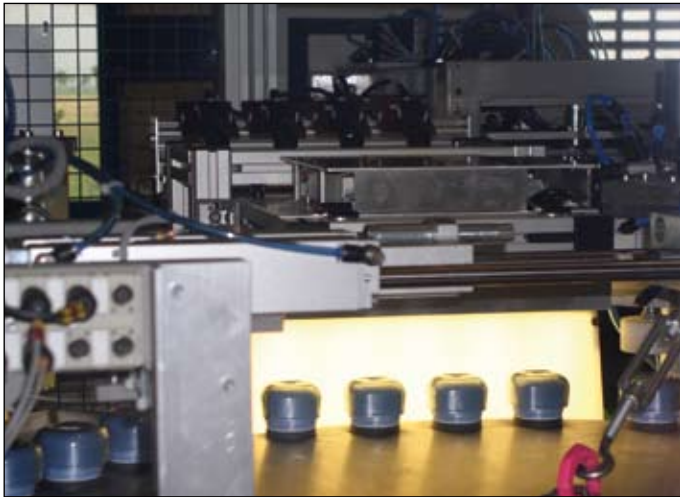
Position of the side wall inspection

On a top plate four containers are mounted in a row and inspected in the next cycle. The cycle time is approx. 4 seconds, 3 seconds of which is standstill time. In these 3 seconds all four jars are turned around once and eight images per revolution are acquired – altogether 32 images. The four progressive scan cameras are triggered by a light sensor arrangement. As soon as the group of four objects arrives in the next station for packing, the result has to be present and the grip arm rejects the bad parts. The sidewall inspection is supplemented by an inspection of the bottom of the containers, which is carried out on each jar on the conveyor before the final assembly.
